EPISODE 51

Pay attention to these
common O&M problems
with inverters in the winter time

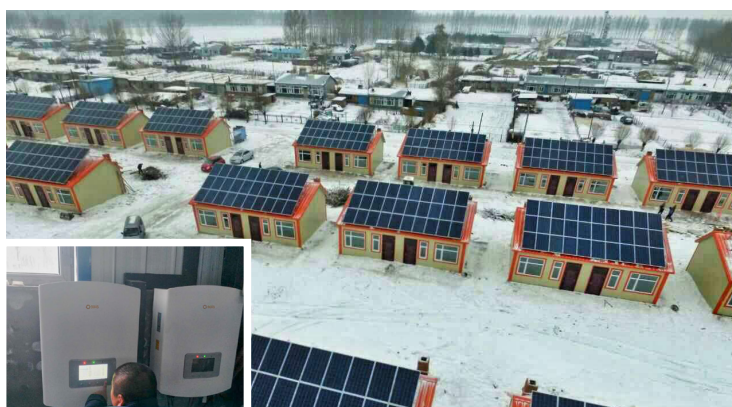
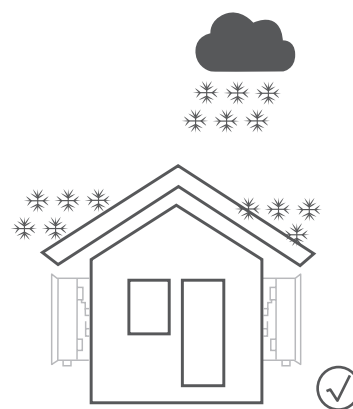
Snow removal in winter is one of the important links in the operation and maintenance of photovoltaic power stations. For inverters, the surrounding snow should be removed, especially at the top and bottom. The snow on the top will damage the stability of the inverter installation structure and could cause serious damage to the shell. Snow at the bottom may bury the AC/DC ports and communication devices, which may cause fault alarms, such as leakage current, or affect communication. Use a flexible and dry tool, such as a shovel, to clear the snow. Do not damage the inverter housing or AC/DC cables during the cleaning process.

If conditions permit, we suggest to install snow retaining equipment for the inverter or installing the inverter in sheltered places or indoors.

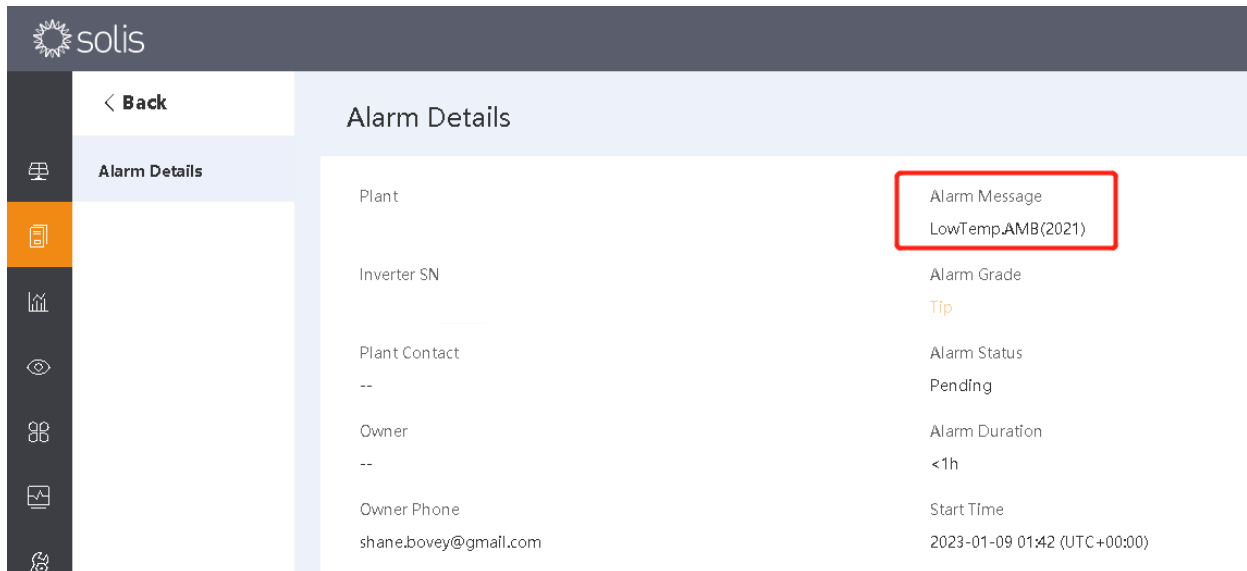
A. LowTemp.AMB:

This fault is common and is caused by the low ambient temperature(Low ambient temperature may cause the inverter to fail to connect to the grid or shut down).

Check whether the ambient temperature is too low and restart the inverter.

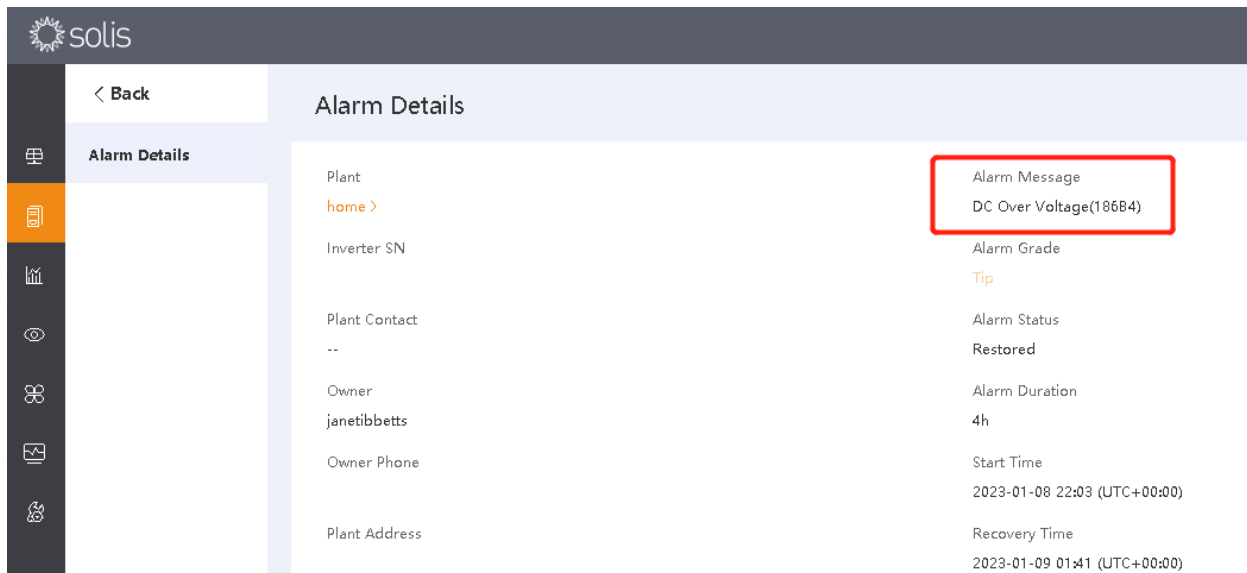
B. DC Over Voltage:

The early design of the power station did not consider the PV string voltage increase caused by the extreme low temperature that may occur in this area.

1. Use a multimeter to check whether the input voltage exceeds the maximum input voltage of the inverter
2. Restart the inverter
3. If still not excluded, please contact Solis customer service.

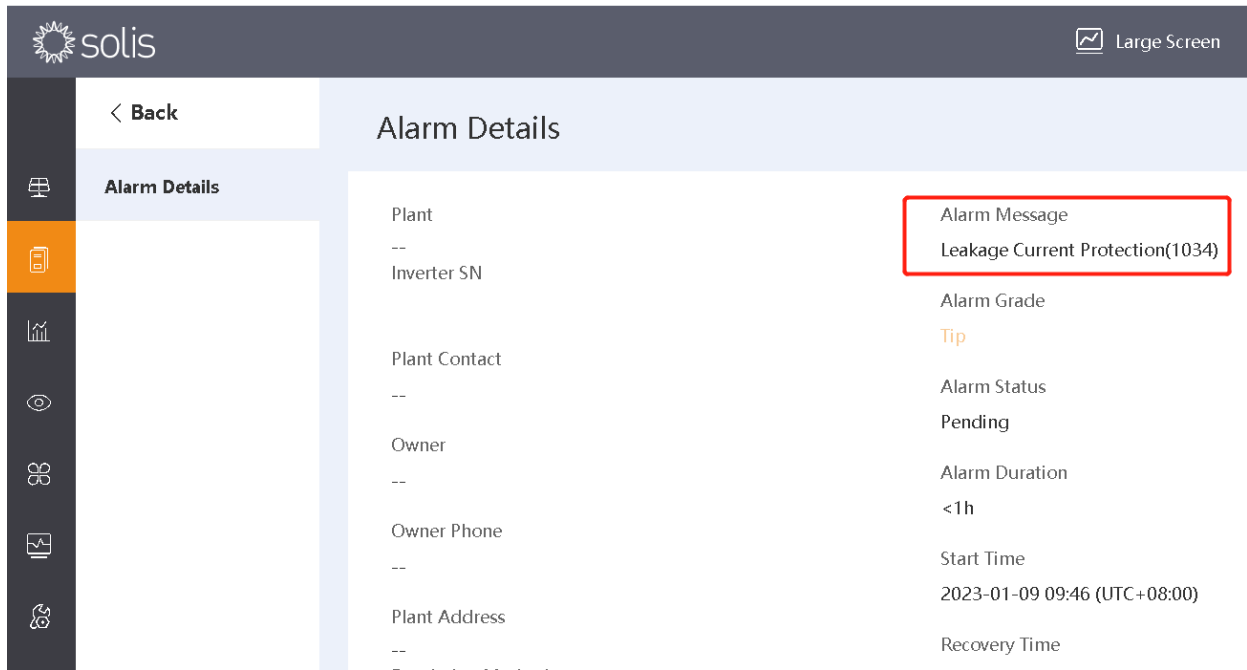
D. Leakage Current Protection:

The main reason that this fault occurs is similar to PV Isolation Protection. In most cases, due to the increase of water in the environment, the photovoltaic module has large parasitic capacitance to the ground, or the cables and connections are soaked (water), worn, or exposed. Therefore, the inverter reports leakage current.

1. Connect each string component individually to determine if it is caused by a component problem. If there is no error when inserting one of the string components, it can be determined that it is a string problem. Check whether the string in question is broken or not.
2. If this error is only caused by a after snowmelt day or a certain time of the morning, it is because the aging of the module causes the leakage current to be too large. When the weather is fine or the air humidity is reduced, the error will be cleared automatically. This can be resolved through remote upgrade software, for details, consult the official Solis service platform
